WRDC-TR-89-3027

SUPERPLASTIC FORMING OF ALUMINUM (TASK C)

Fairchild Republic Company Farmingdale, NY 11735

Final Report for Period March 1986 - January 1988

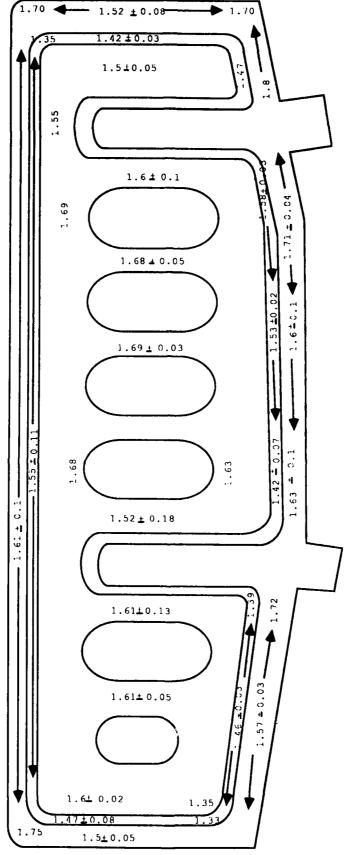
One formed and heat treated part was subjected to a detailed thickness survey. The minimum thickness found was .024" located at the root radius of the pan features 1 through 6 (see subsection 2 of this appendix, A.2). This represents 238% equivalent strain.

Figure A2-7: Thickness Survey of Entire Door A.2-9

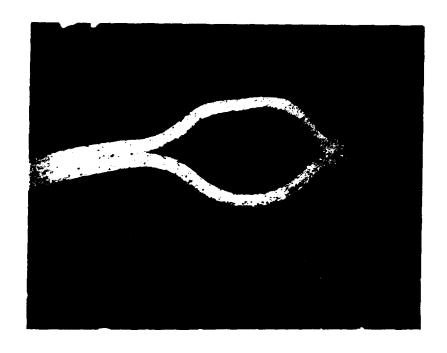
The occurrence of isolated blisters appears to be associated with hydrogen gas and localized oxide films. This may have arisen from porosity in the experiment block which failed to "heal" when rolled from block to sheet. This defect will be investigated further.

Figure A3-4. Center line blister at location M2 (10X)
